W E E K L Y O P E R A T I O N S R E P O R T

I. DOCUMENT ID#: CPI-OPS-7601-200309-AM1
II. TITLE: TAYLOR COGEN GONZALES WEEKLY OPERATIONS REPORT
III. START DATE: 03/09/20
IV. END DATE: 03/15/20

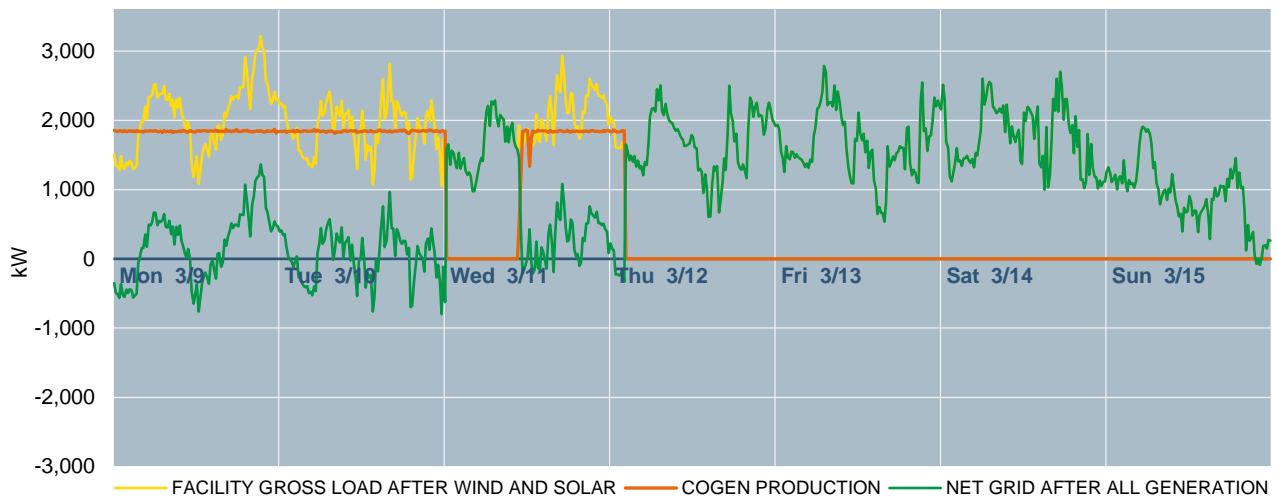
V. KEY METRICS:
 Cogen Production: 116,841 kWh
 % of Gross Load Served: 41.2%
 Net Grid After All Generation: 166,978 kWh
 Net Exports: 6,985 kWh
 Cogen Run-hours: 64.75 run-hours
